Manhole Inspection Summary

Manhole # S55G__007MH

Inspection ☐ Is Incomplete Rating: **4) Poor**

Location Address: **Gough St.**

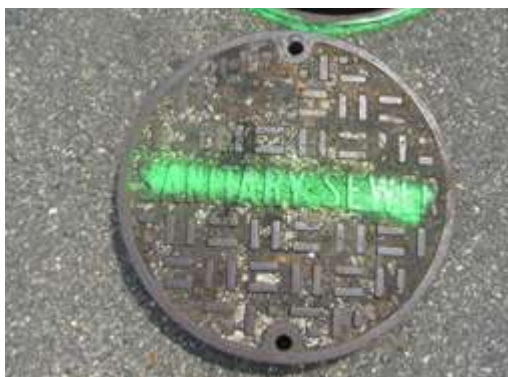
Miscellaneous

MH Lid

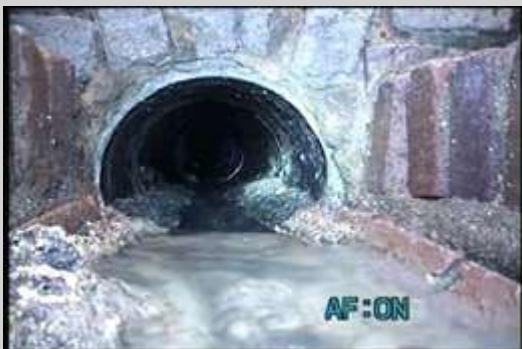
6 O'Clock Inflow

8 in. Circular Gravity Sewer
Pipe In @ 6 O'Clock

Pipe Height: **8.4** (in.) Rod and Bar (Angled)
Pipe Material: **Clay** ☐ Pipe Lined
Invert Depth: **8.78** (ft.) Flow Characteristics: **Slow**
Deposits: ☒ None ☐ Mud ☐ Sludge ☐ Debris ☐ Grease
Silt Depth: **0** (in.) Deposits Extent:
Infiltration: **None** Pipe Seal Cond: **Sound**

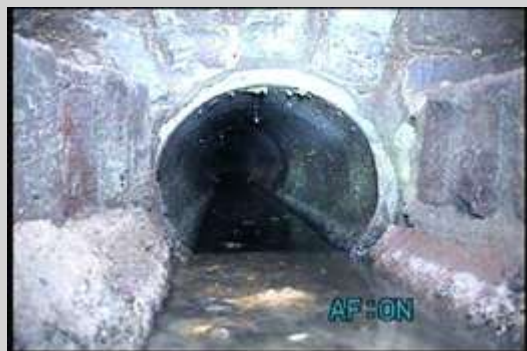
9 O'Clock Inflow

8 in. Circular Gravity Sewer
Pipe In @ 9 O'Clock

Pipe Height: **7.2** (in.) Rod and Bar (Angled)

Pipe Material: **Clay** ☐ Pipe Lined

Infiltration: **None**
